Explosive Concrete Spalling during Large-Scale Fire Resistance Tests

Maluk, C, Bisby, L & Terrasi, GP 2016, Explosive Concrete Spalling during Large-Scale Fire Resistance Tests. in *9th International Conference on Structures in Fire*. Princeton.

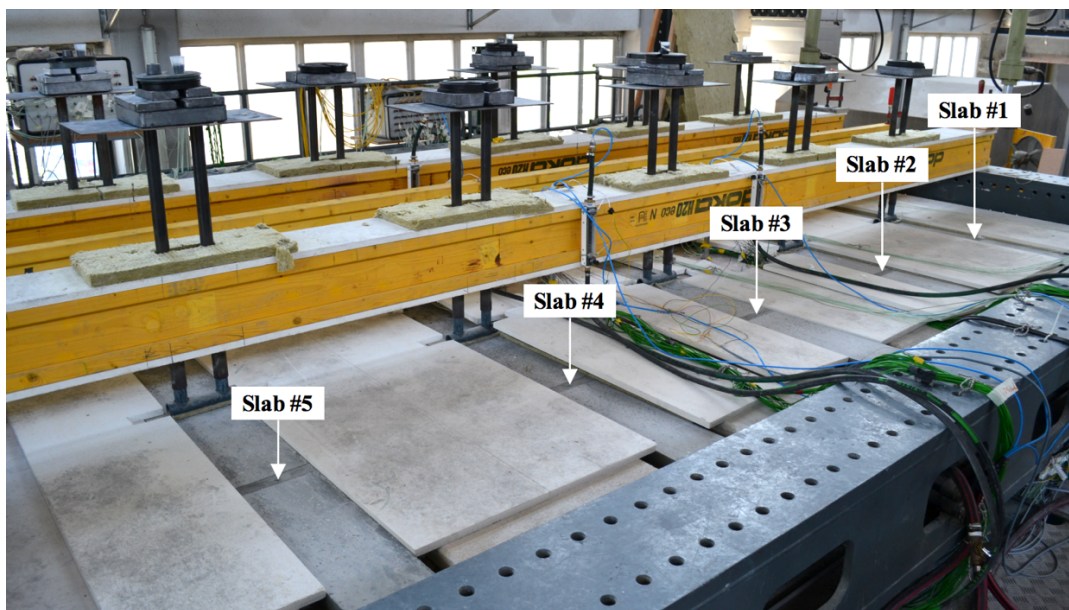
Figure 1. Photo of the fire resistance test setup showing positions of the respective slabs and sustained loading technique used.

Within the scope of the work presented and discussed herein a careful thermal analysis of the tested slabs is done for one of the large-scale fire resistance tests (referred to Figure 1). A comparison of in-depth temperature distributions inside concrete slabs shows that spalling occurred for slabs with more rapid in-depth temperature increase.

A set of large-scale fire resistance tests were executed, each with five loaded prestressed concrete slabs simultaneously tested in a standard floor furnace test [5]. The design and test program of the prestressed slabs was aimed to evaluate the influence of: age of concrete, inclusion of polypropylene fibres, depth of the slab, and prestressing level. The parameters evaluated for the test examined within this paper is shown in Table 1 (refer to Figure 1).

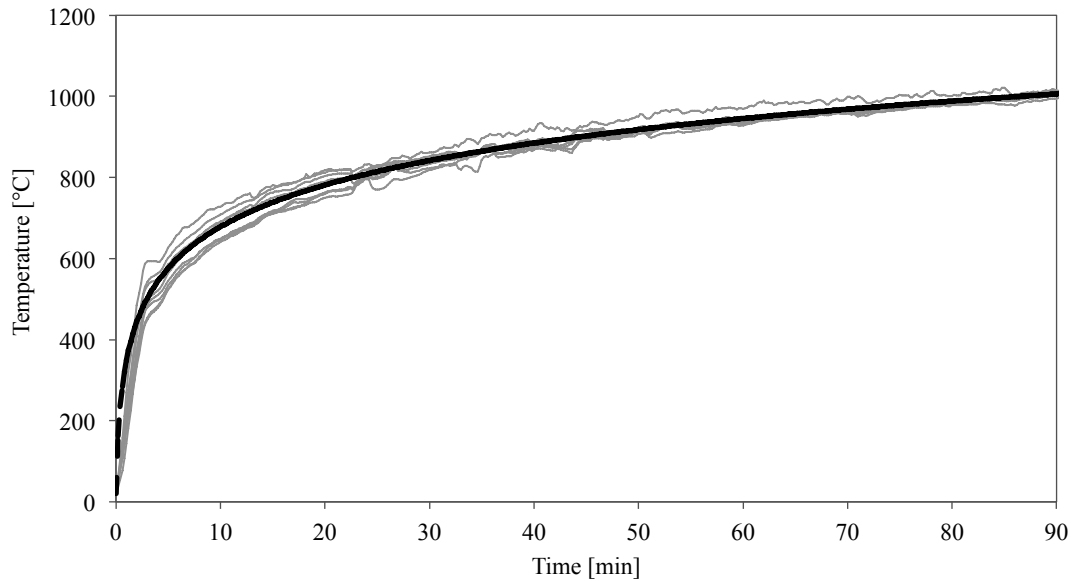
Figure 2. Furnace gas temperatures measured by the plate thermometers along with the objective standard time-temperature curve [6].

Temperature measurements from the eight plate thermometers inside the furnace are shown in Figure 2 along with the objective time-temperature curve. Although compliant with the testing standard [6], the temperature measurements show substantial deviation in the temperature measured inside the furnace, especially during the first 20 minutes (see Figure 3). Due to the obvious technical challenge of precisely controlling the furnace to follow the rapidly growing prescribed time-temperature curve [6] during early stages of the test, most testing standards do not prescribe an allowable deviation during the first 5 minutes (see Figure 3).

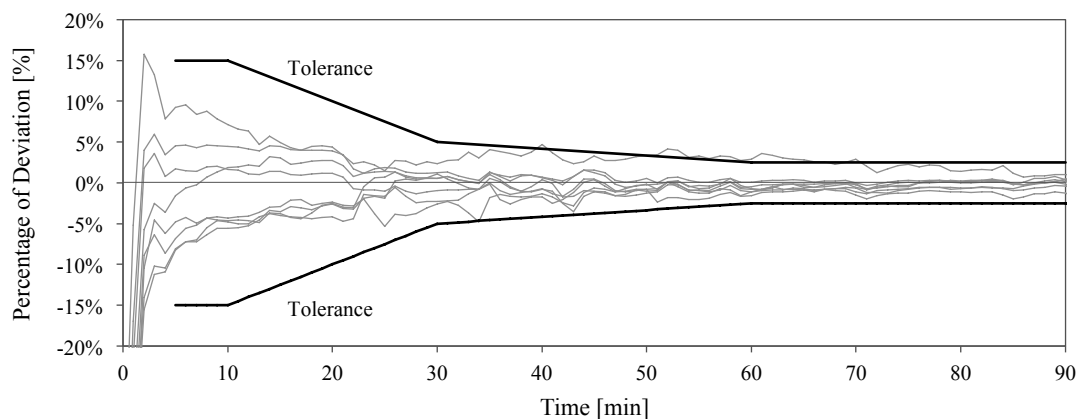
Figure 3. Percentage of deviation of the temperature measured by plate thermometers from that of the objective temperature, and the maximum allowable deviation (tolerance) [6].

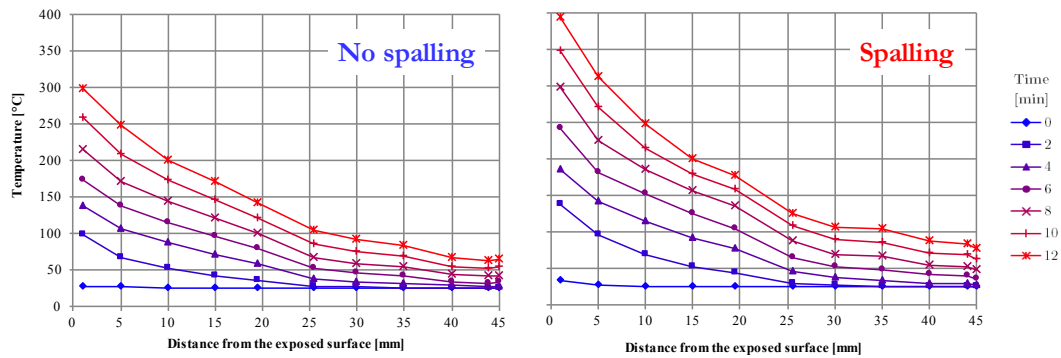
Figure 4. In-depth temperature distribution for identical slabs; Slab #1 (left plot) that did not spall and Slab #2 (right plot) that spalled 12 minutes from the start of the test (refer to Table 1).

In-depth temperature measurements were taken at midspan of the slabs. Temperature was measured in up to eleven positions from the exposed surface of each of the slabs. Special care was taken during the casting process to ensure precise placement of thermocouples at the intended location inside the slabs. A comparison of in-depth temperature distributions measured at midspan is shown in Figures 4. Temperature for the first 12 minutes of a test are shown.

Considerable variation of in-depth temperature distributions was observed for slabs with equivalent thickness, demonstrating poor homogeneity of the thermal exposures for slabs tested simultaneously during a single furnace test; this is despite the temperatures measured by the plate thermometers complying with the test standard (see Figure 3). Slabs with more rapid temperature increase spalled, while slabs with relatively slower temperature increase did not spall. This suggests the important influence of the thermal exposure, hence transient evolution of thermal gradients, in the occurrence of heat-induced concrete spalling [7].

Slab #2 failed after 12 minutes, whereas the virtually identical Slab #1 failed due to loss of anchorage after 42 minutes of fire exposure (refer to Table 1); Figure 13 shows that Slab #2 experienced more rapid heating during the early stages of the test. This suggests a possible important influence of the time-history of in-depth temperatures on the occurrence of heat-induced concrete spalling [1]. For instance, Slab #2 spalled when the measured temperature 1 mm from its exposed surface was 400°C, while for Slab #1 the temperature at the same location was only 300°C. The possibility that this was due to misplacement of thermocouples during casting was discarded since equivalent temperature differences between slabs #1 and #2 were observed for temperatures measured at various positions in the slab (e.g. 5, 10, and 15 mm from the exposed surface).

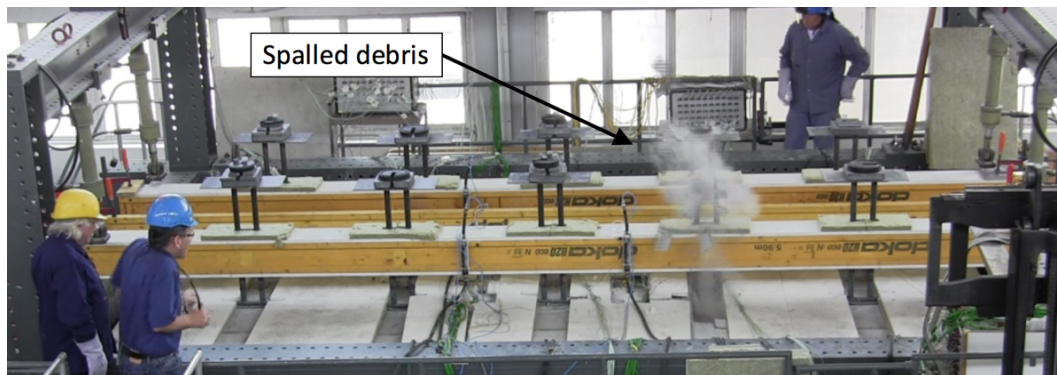
Figure 3. Explosive spalling and immediate collapse of a large-scale slab during a fire resistance test.

Failure of slabs #2 and #3 was driven by the occurrence of single explosive concrete spalling events, 12 and 22 minutes from the start of the test, respectively (refer to Table 1). Immediately after spalling, each of these slabs suffered catastrophic failure and collapsed into the furnace. Video stills recorded during testing showed the moment at which spalling occurred (shown for Slab #2 in Figure 19).
